# NATIONAL BUREAU OF STANDARDS REPORT

## DEVELOPMENT, TESTING, AND EVALUATION OF VISUAL LANDING AIDS

Consolidated Progress Report

July 1 to September 30, 1968

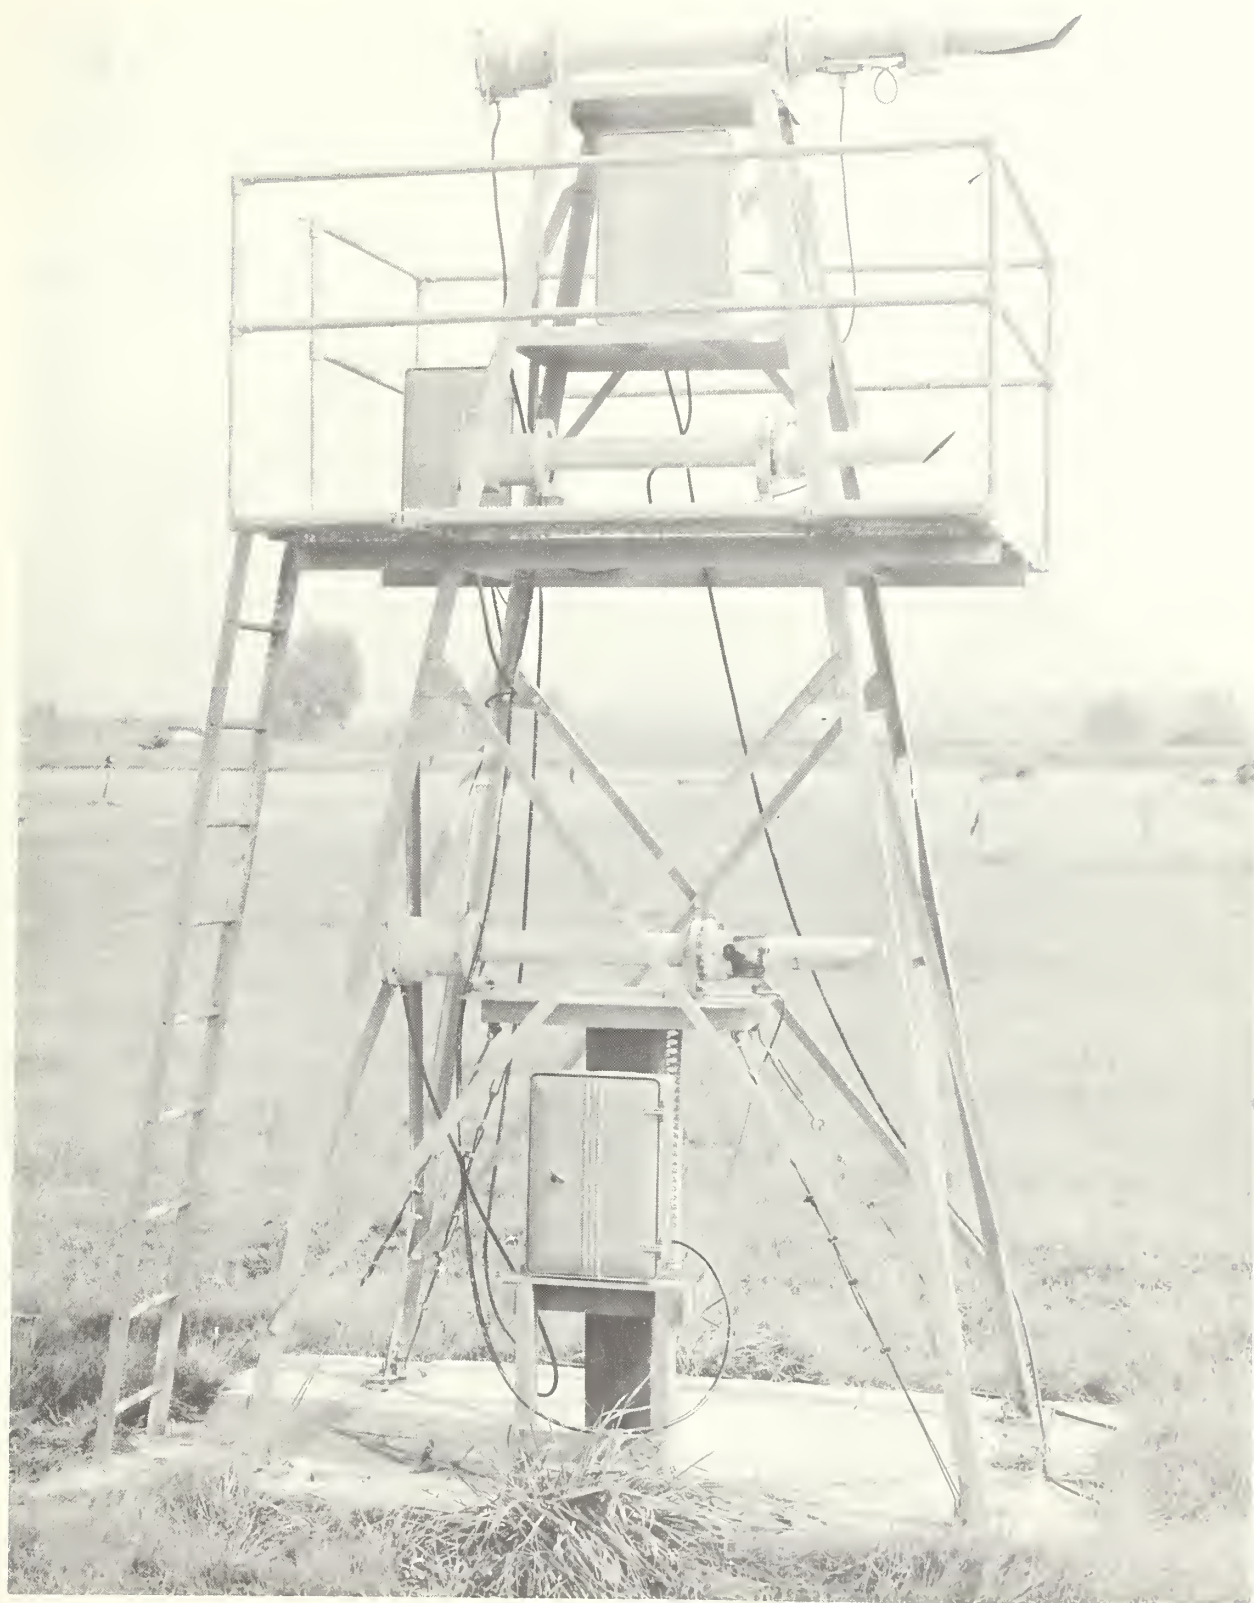
Figure 6. Transmissometer receiver installation to determine effect of height on transmission tests.

The installation for preliminary investigation of the effect of height on atmospheric transmission was completed at the beginning of this quarter. Three transmissometers using the same 250-foot baseline are installed with one at 5 feet, one at 10 feet, and one at 15 feet above the ground. These units are

located at the site previously designated as T. L2 transmissometer. The installations of the projectors and receivers are shown in figures 1 and 6. The indicators and recorders are located in the Field Laboratory. In advection fogs, usually the top transmissometer indicates the lowest transmittance. In radiation or ground fog, which is less common at Arcata, the bottom transmissometer usually indicates the lowest transmittance. The center transmissometer seems to agree more nearly with the top unit than with the bottom unit. This may indicate that the ground effect on fog density is most noticeable in the first five feet, but extends above 15 feet. Frequently the fog density changes rapidly, and the normal recorder chart drive speed of 3 inches per hour is too slow to adequately correlate the three records with the time variations. On several occasions the chart drive speed was changed to 12 inches per hour, which permits the variations with time to be followed satisfactorily. These transmissometers operating as the test installation will be continued.
